**Sea Monarch Condominiums, Inc.**  
**SIRS Components**  
***Pompano Beach, FL***

Report #: 24498-9  
Beginning: January 1, 2025  
Expires: December 31, 2025

**RESERVE STUDY**  
**Update "With-Site-Visit"**

October 23, 2024

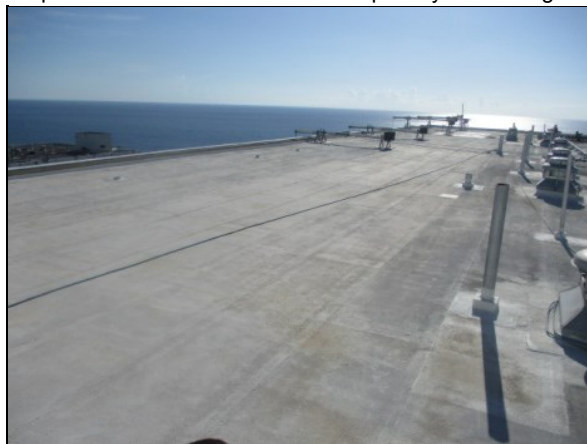
Useful Life:  
20 years

Remaining Life:  
5 years

Best Case: \$ 866,000

Worst Case: \$ 1,066,000

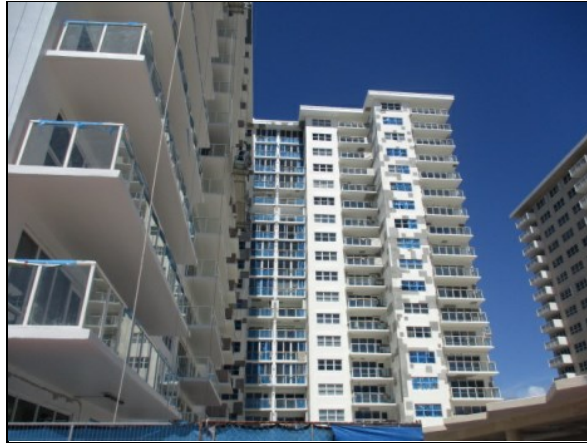
Useful Life:  
7 years

Remaining Life:  
7 years

Best Case: \$ 852,000

Worst Case: \$ 1,052,000

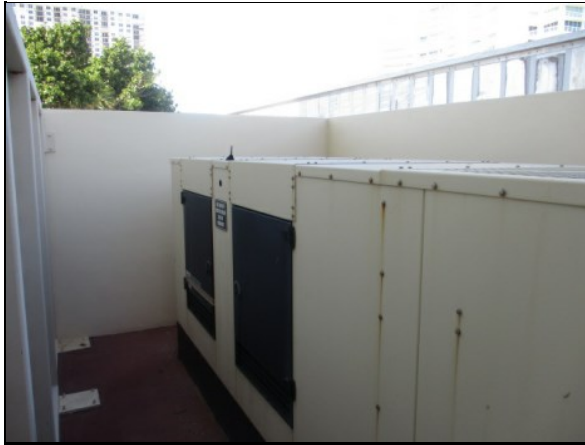
**Comp #: 2549 Generator - Replace****Quantity: (1) Generator**

Location: Exposed location adjacent to building

Useful Life:  
30 years

Remaining Life:  
17 years

Best Case: \$ 125,000

Worst Case: \$ 175,000
