STRUCTURAL SAFETY INSPECTION REPORT FORM

1. DESCRIPTION OF STRUCTUREa. Name on Title: Sea Monarch Condominium, Inc.b. Street Address: 111 N. Pompano Beach Blvd, Pompano Beach, FL 33062c. Legal Description: SEA MONARCH CONDO COMMON AREA BK/PG 4346/570d. Owner's Name: Sea Monarch Condominium, Inc.e. Owner's Mailing Address: 111 N. Pompano Beach Blvd, Pompano Beach, FL 33062f. Email Address: vburnette@castlegroup.com Contact Number: 954-781-0350g. Folio Number of Property on which building is located: 8331BBCOMMh. Building Code Occupancy Classification: R-2 Residentiali. Present Use: Residentialj. General Description: _____ Type of Construction: Type 1k. Square Footage: ~29,557 SF Number of Stories: 19
 l. Is this a Threshold Building (per F.S. 553.71): ☒ Yes ☐ No

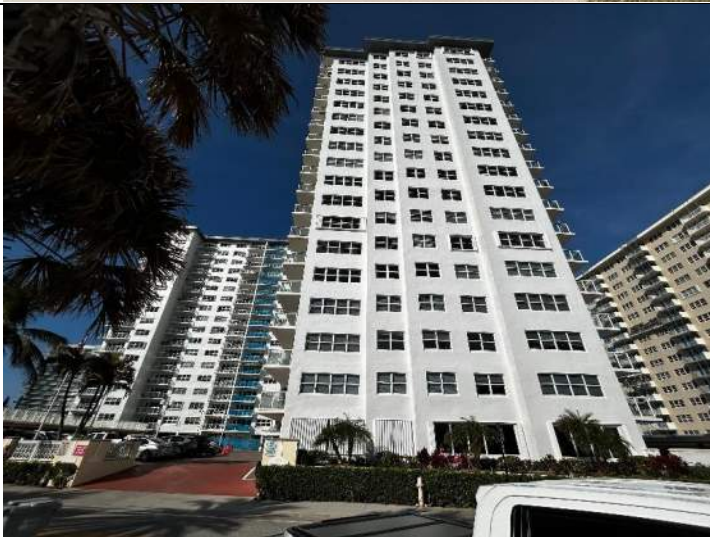
Partial East elevation
taken from the South
driveway

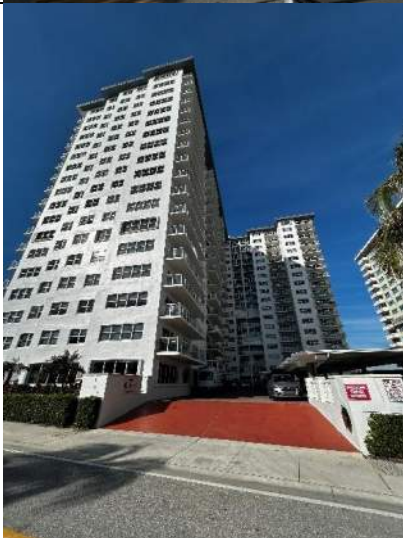
Partial East elevation
taken from the North
driveway

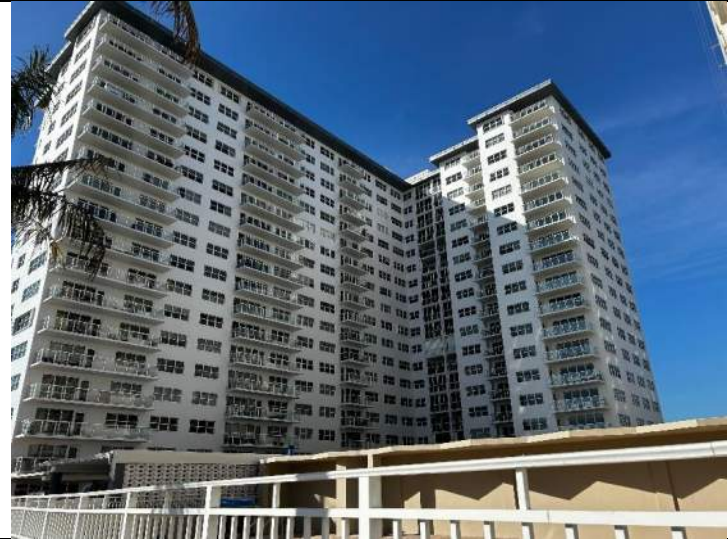
<p>North elevation with partial east elevation taken from neighboring</p>

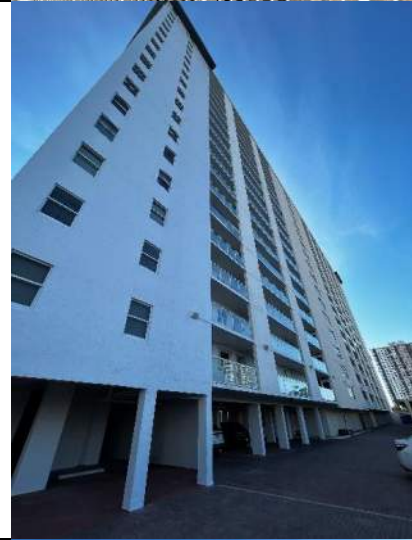
<p>Northwest elevation taken at lobby level – railings and windows in good condition</p>

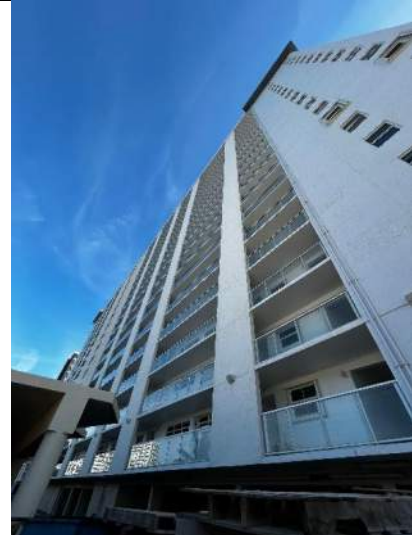
<p>Southwest elevation with new carport on west side</p>

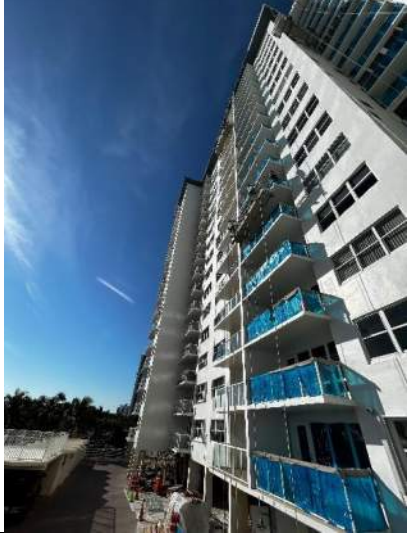
<p>Ongoing restoration project addressing balcony and stucco repairs</p>

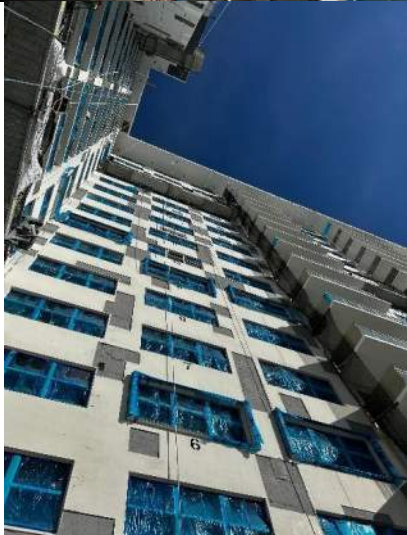
<p>Ongoing restoration project addressing stucco repairs</p>
 		<p>Ongoing restoration project involving stucco and column repairs</p>

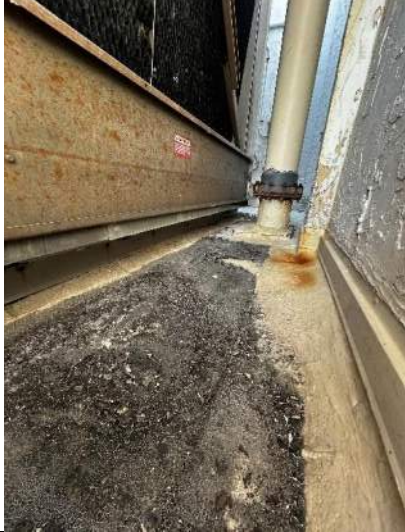
Roof-top support for cooling tower was found to be intact with galvanized coating. Corrosion was observed along the rear of the unit framing and corroded through the ladder anchor connections as well.

Steel base support on the cooling tower. Corrosion starting to set in on the rear.

<p>Roof mounted cooling tower framing system</p>

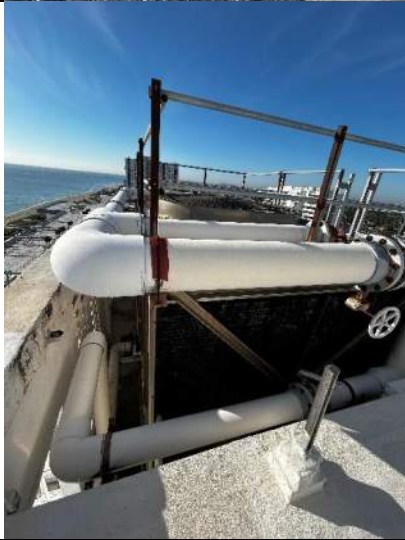
<p>Roof mounted cooling tower overview</p>

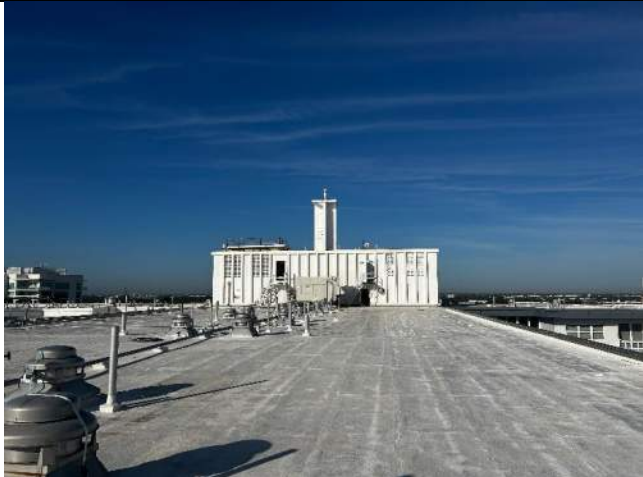
The roof is a reinforced concrete, low-slope, roof slab. The roof is modified bitumen membrane with a white coating. The membrane is in good condition, the coating is in average condition with some spots starting to deteriorate. There is a low-perimeter curb around the edge of the roof but it is not high enough to be considered a parapet wall. Mechanical equipment and ventilators are located on the roof in addition to structural elements like stair towers and elevator tower.

<p>Modified bitumen coated roof overview taken from East end in good to fair condition</p>

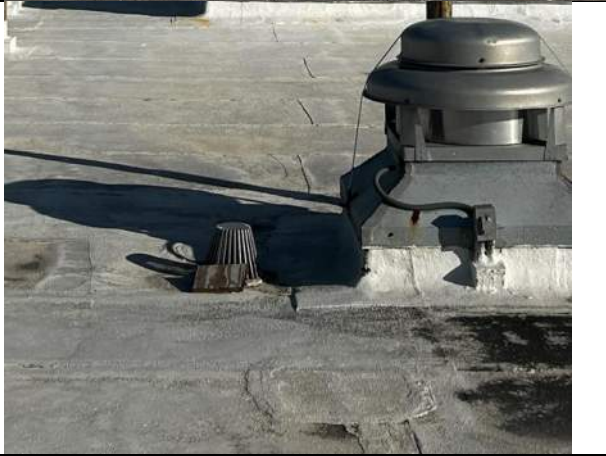
<p>Typical roof drain</p>
 		<p>Elevator equipment on roof in good condition</p>

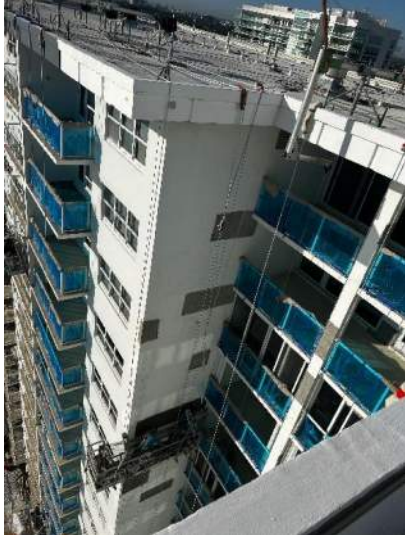
<p>Example of ongoing stucco and balcony restoration</p>

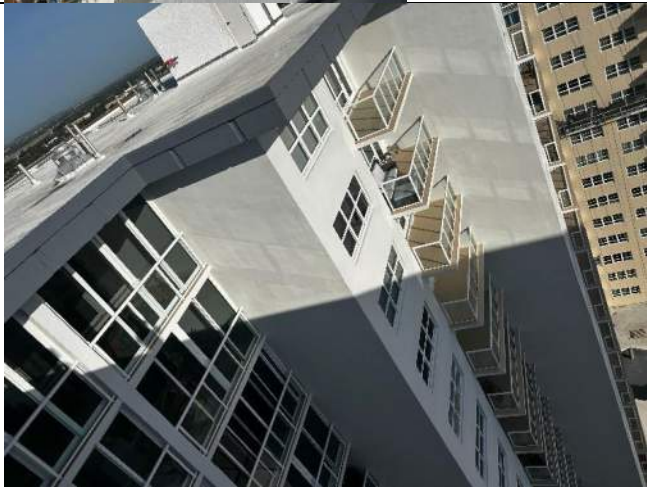
<p>Example of completed balcony and stucco restoration on northeast wing</p>

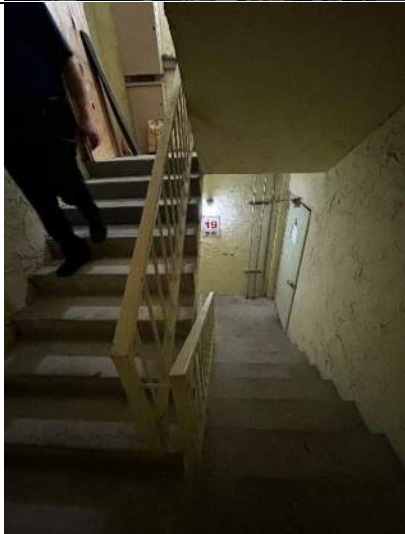
<p>Central stairwell overview</p>

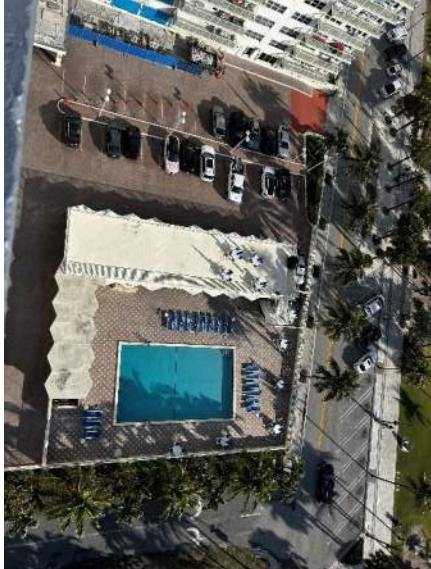
<p>Elevated pool and southeast carport overview – carport is part of the restoration project</p>

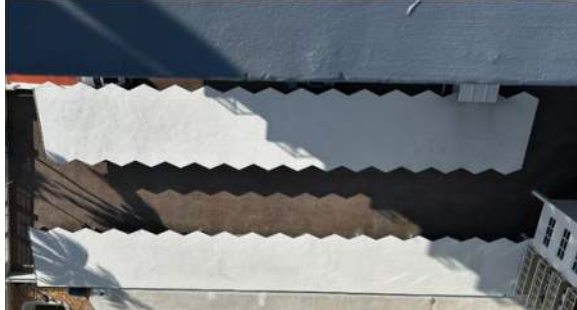
<p>Northeast carports overview – good condition</p>
