Structural Integrity Reserve Study (SIRS)

Pursuant to *Florida Statutes* Ch. 718 and 719

POMPANO AEGEAN CONDOMINIUM ASSOCIATION, INC
1010 SOUTH OCEAN BLVD, POMPANO BEACH, FLORIDA

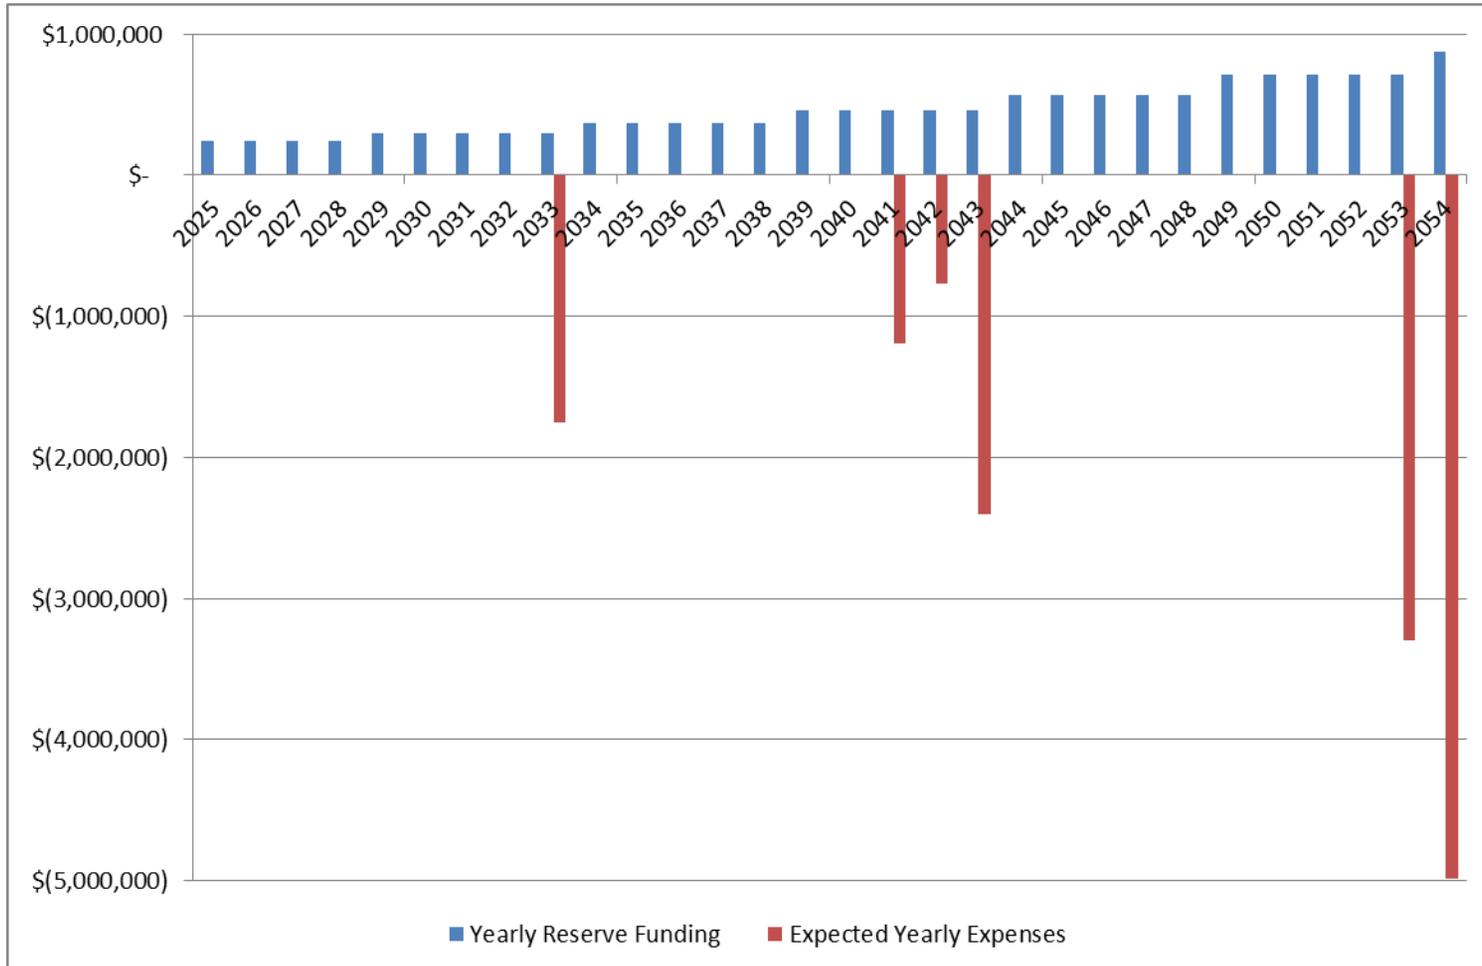
Chart I: Yearly Contributions & Expected Expenses

The chart shows the expenses each year, with peaks corresponding to building repair and roof replacement projects. The *Deferred Maintenance Expenses* are represented as expenditures in the final year of the Study.

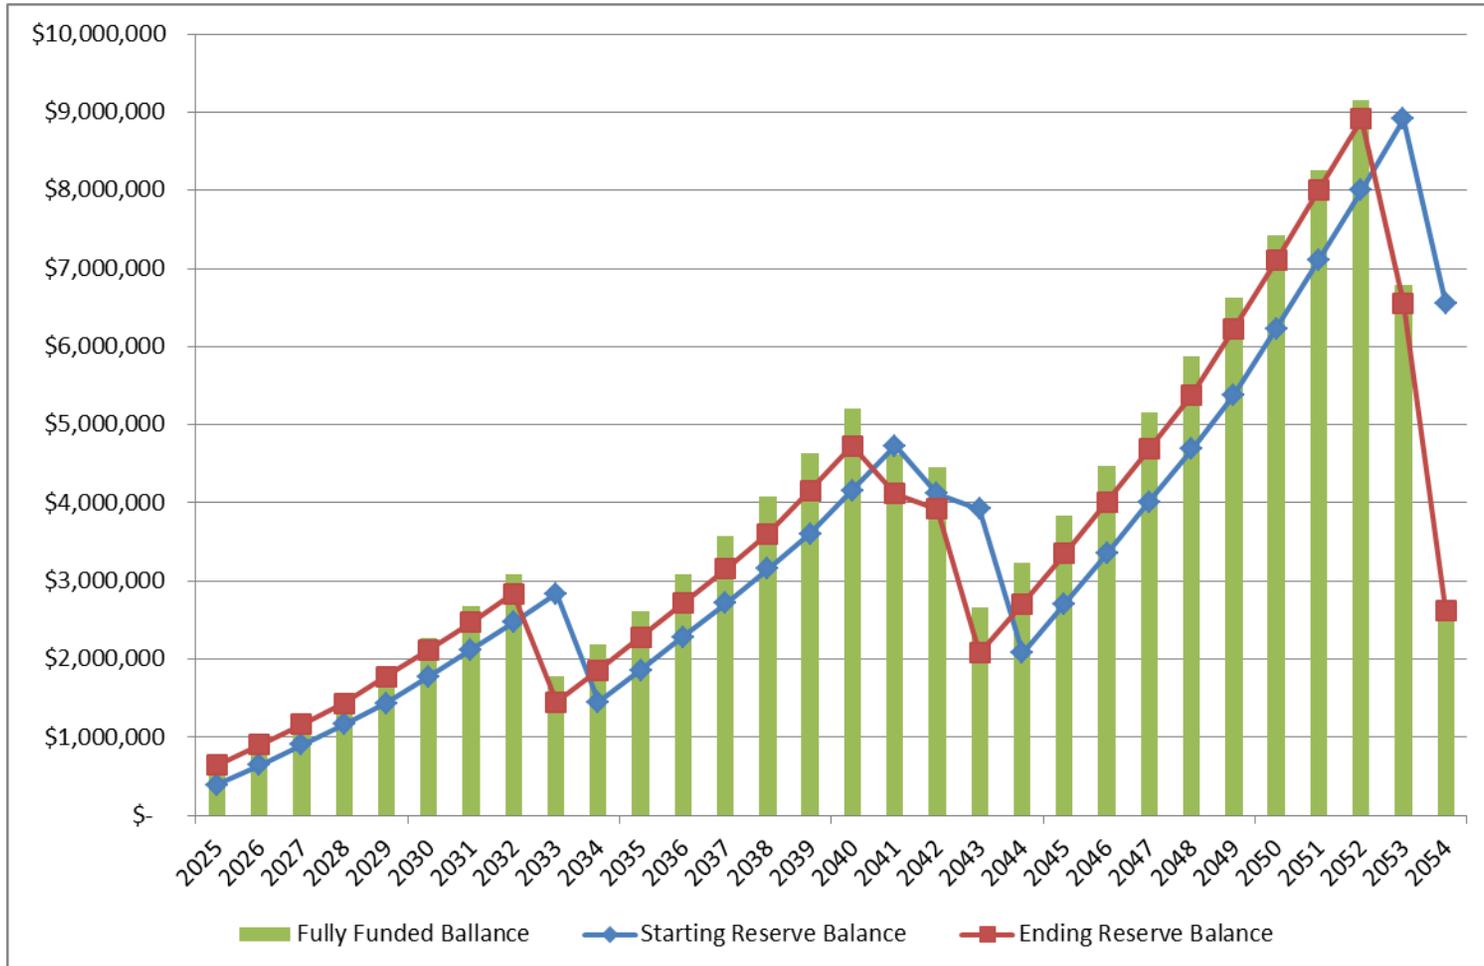
Chart 2: Yearly Reserve Balances

The chart shows the balances each year, with large drawdowns corresponding to building repair and roof replacement projects. The Year 30 reserve balance should approach the *Fully Funded Balance* in year 30. The *Deferred Maintenance Expenses* are represented as expenditures in the final year of the Study.
